BUREAU OF SHIPS GROUP TECHNICAL INSPECTION REPORT

U.S.S. INDEPENDENCE (CVL22)

TEST ABLE

VOLUME 4 OF 4

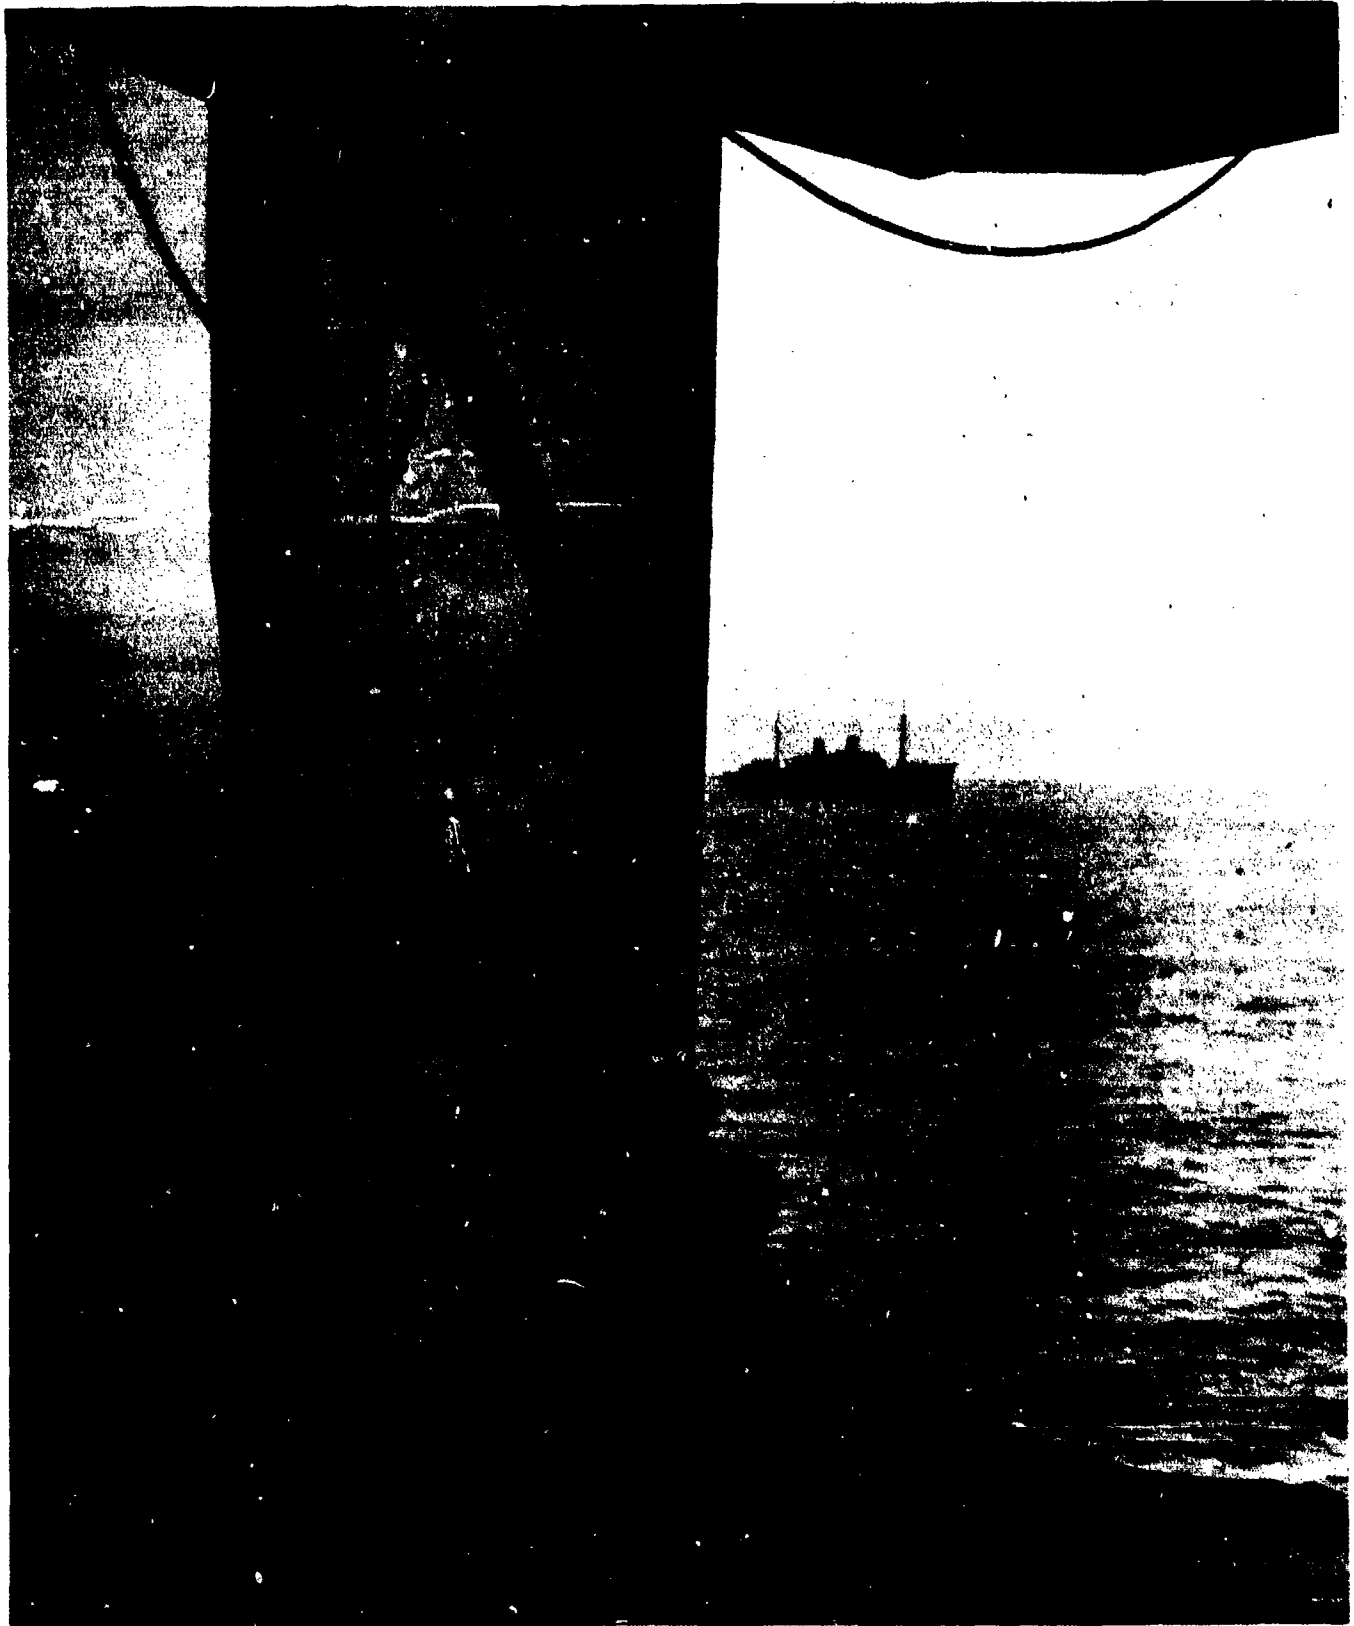
AA-CR-80-170-7. After Baker. Flight deck Bent 104, port bottom, looking aft.

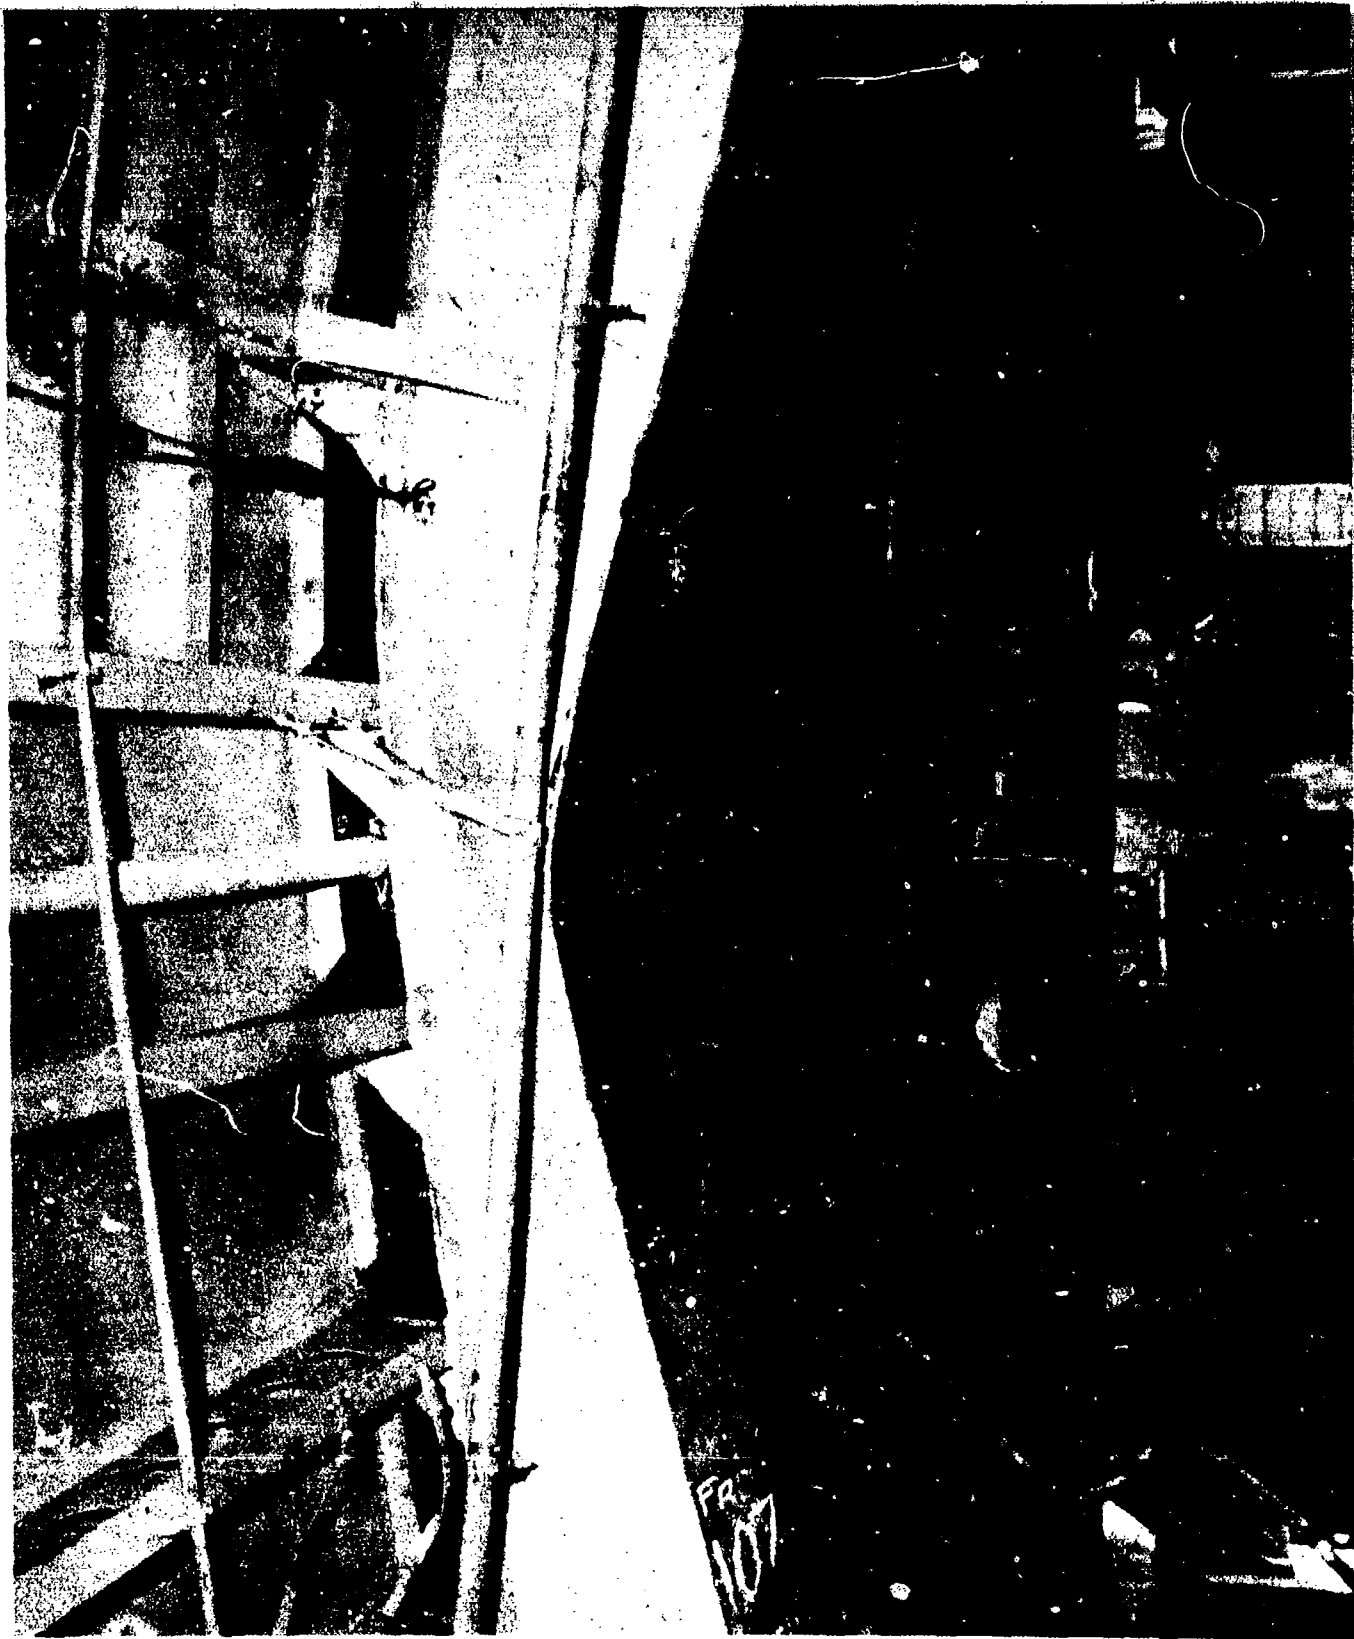
AA-CR-59-4152-2. Flight deck bent girder 107, looking aft, showing buckle to starboard of centerline.

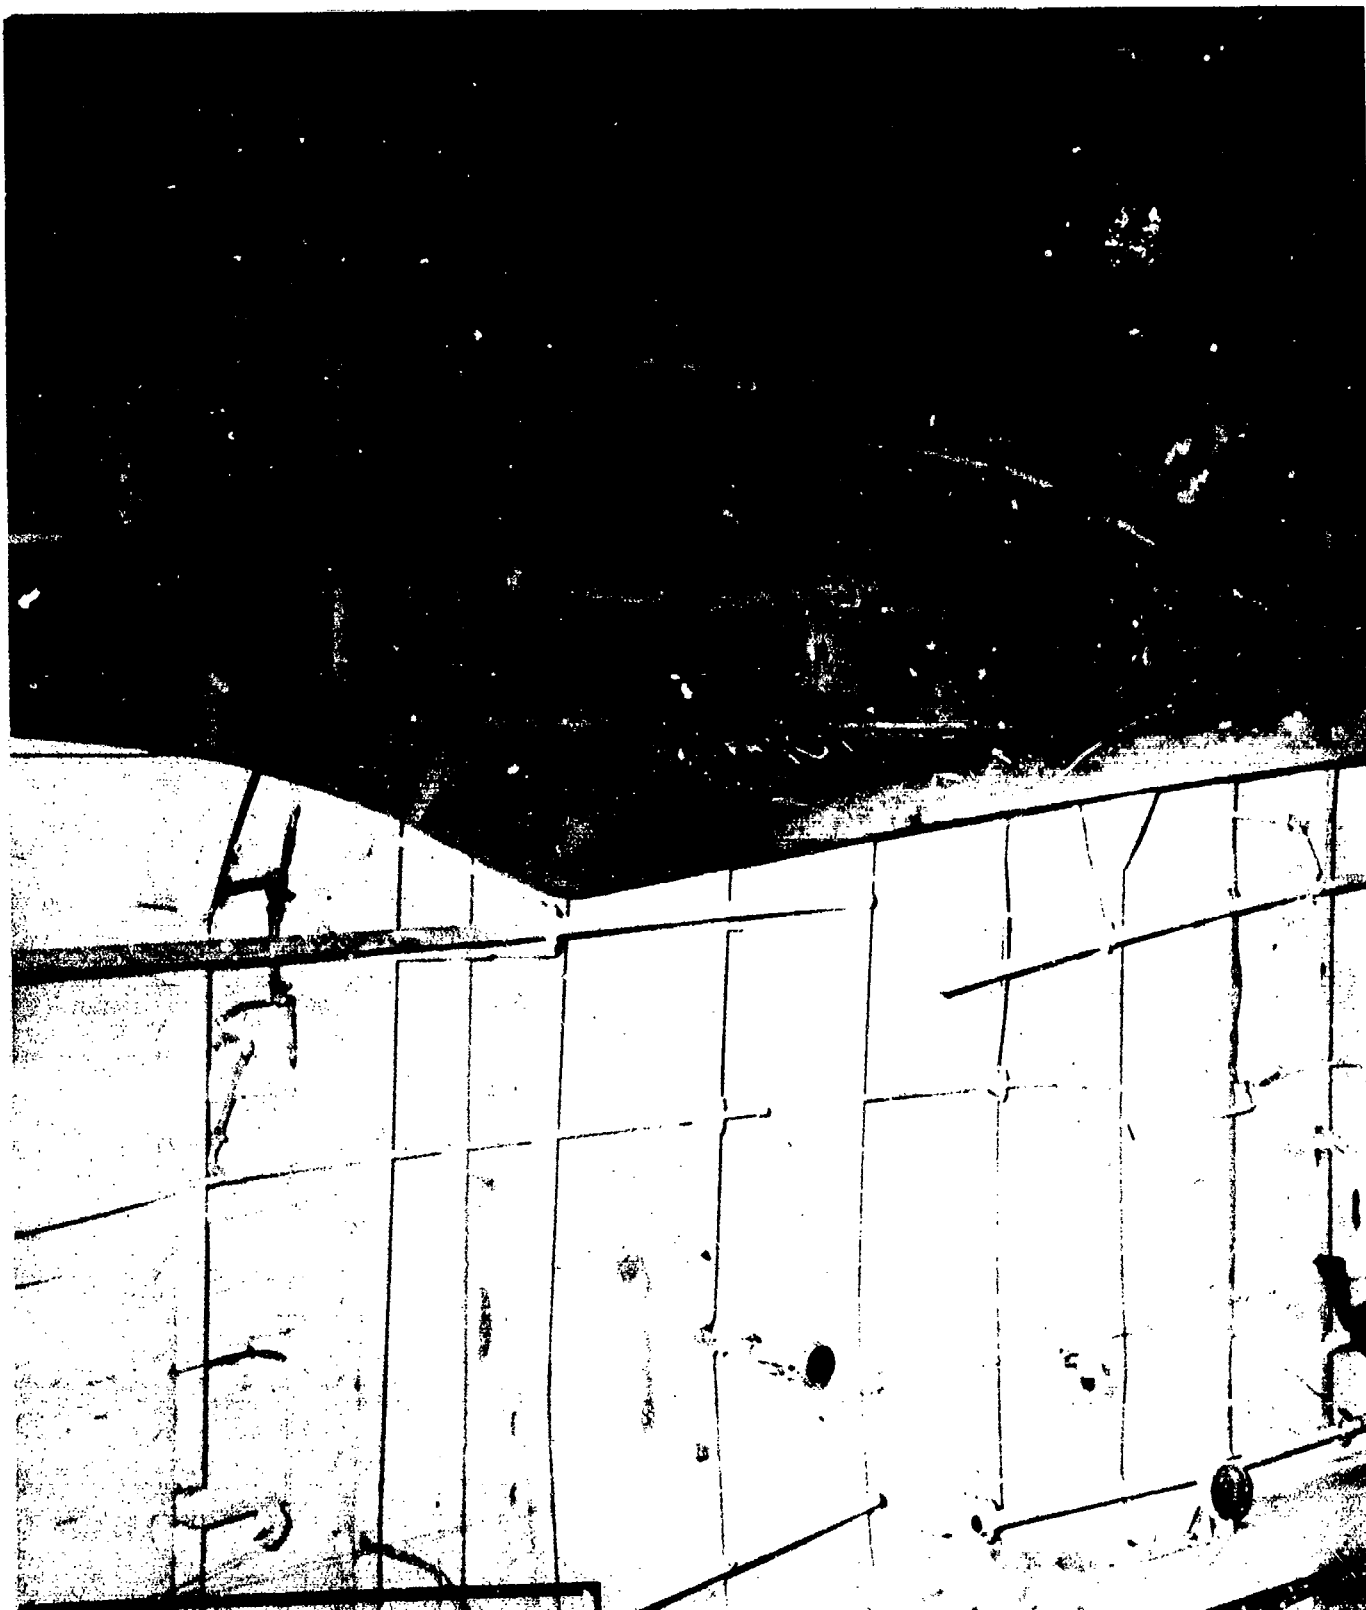
AA-CR-59-4151-7. Flight deck bent girder 107, looking up and to starboard.

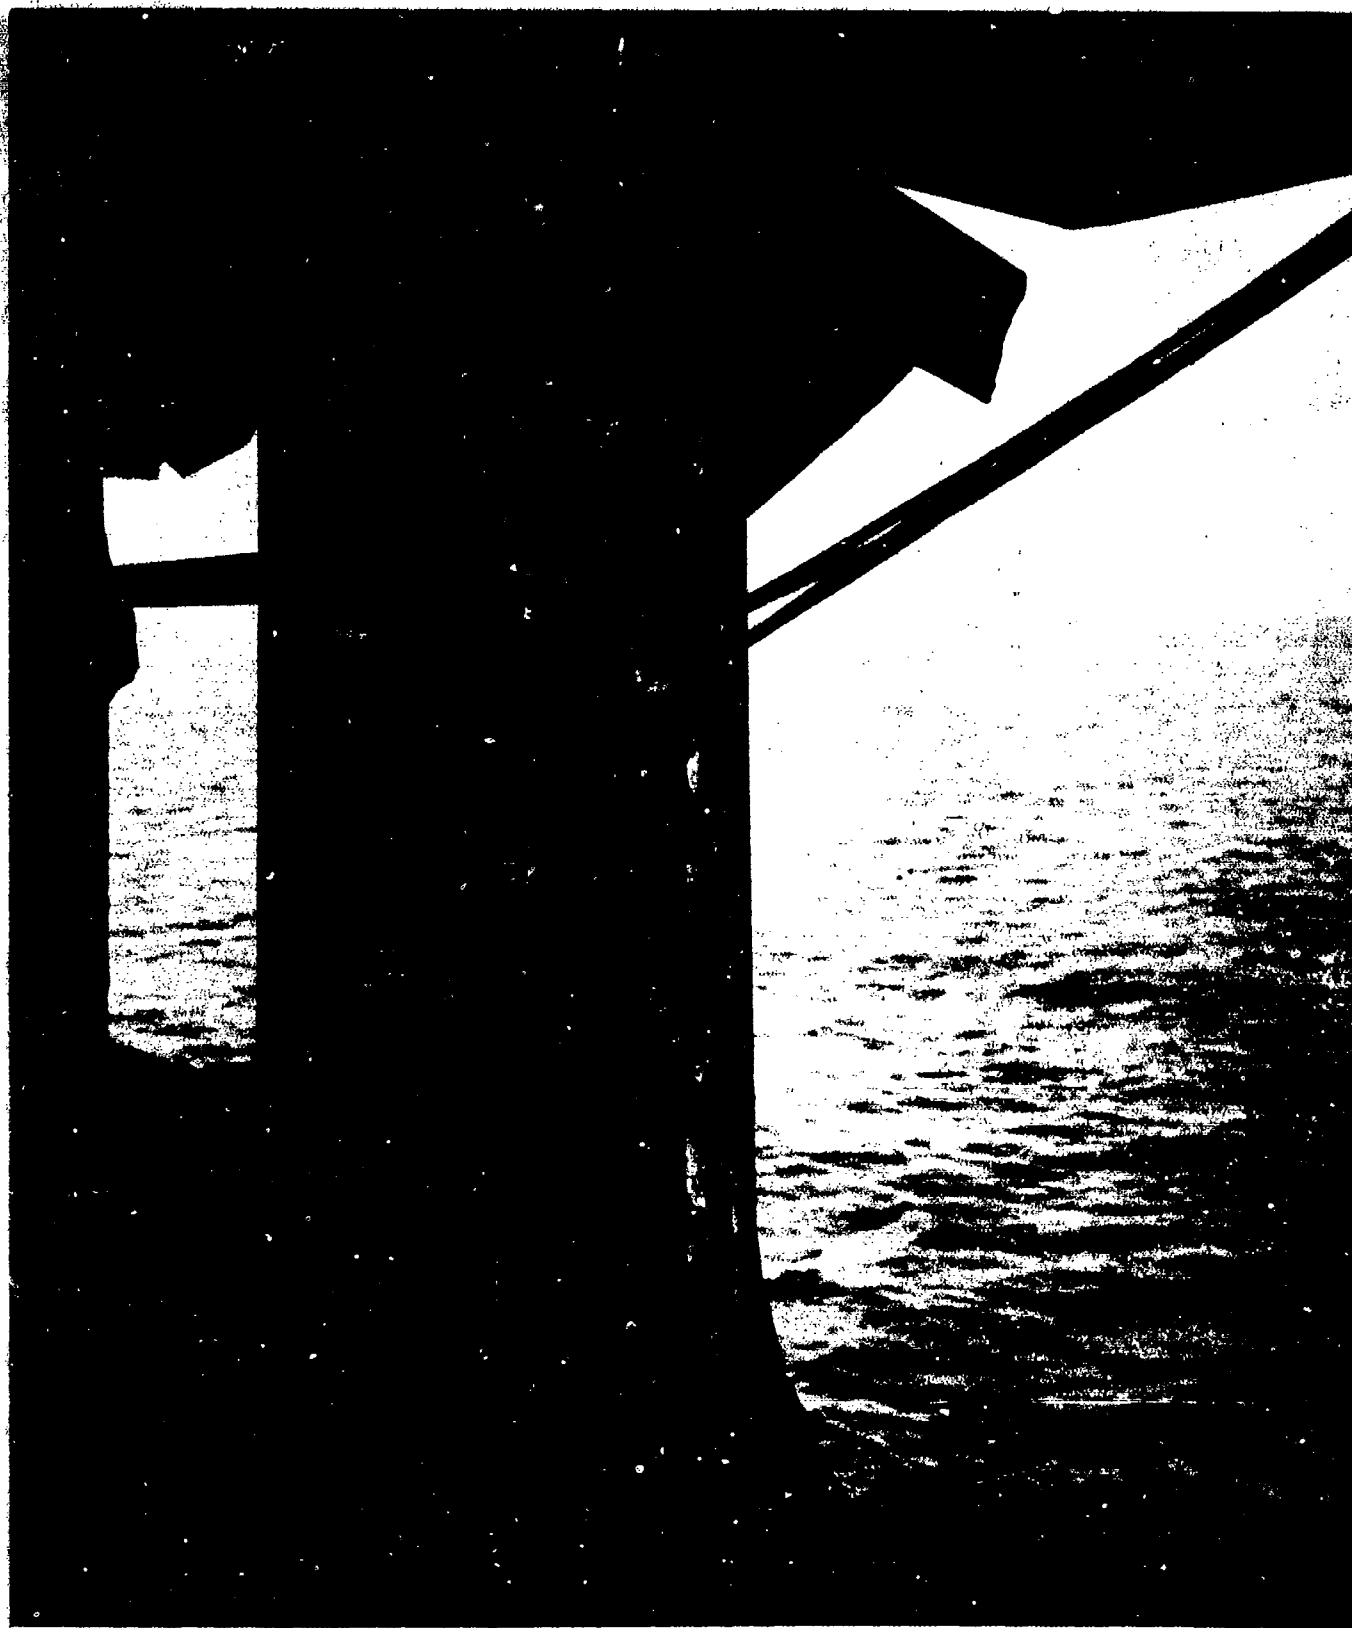
AA-CR-80-170-10. After Baker. Flight deck Bent 107, starboard bottom, looking forward.

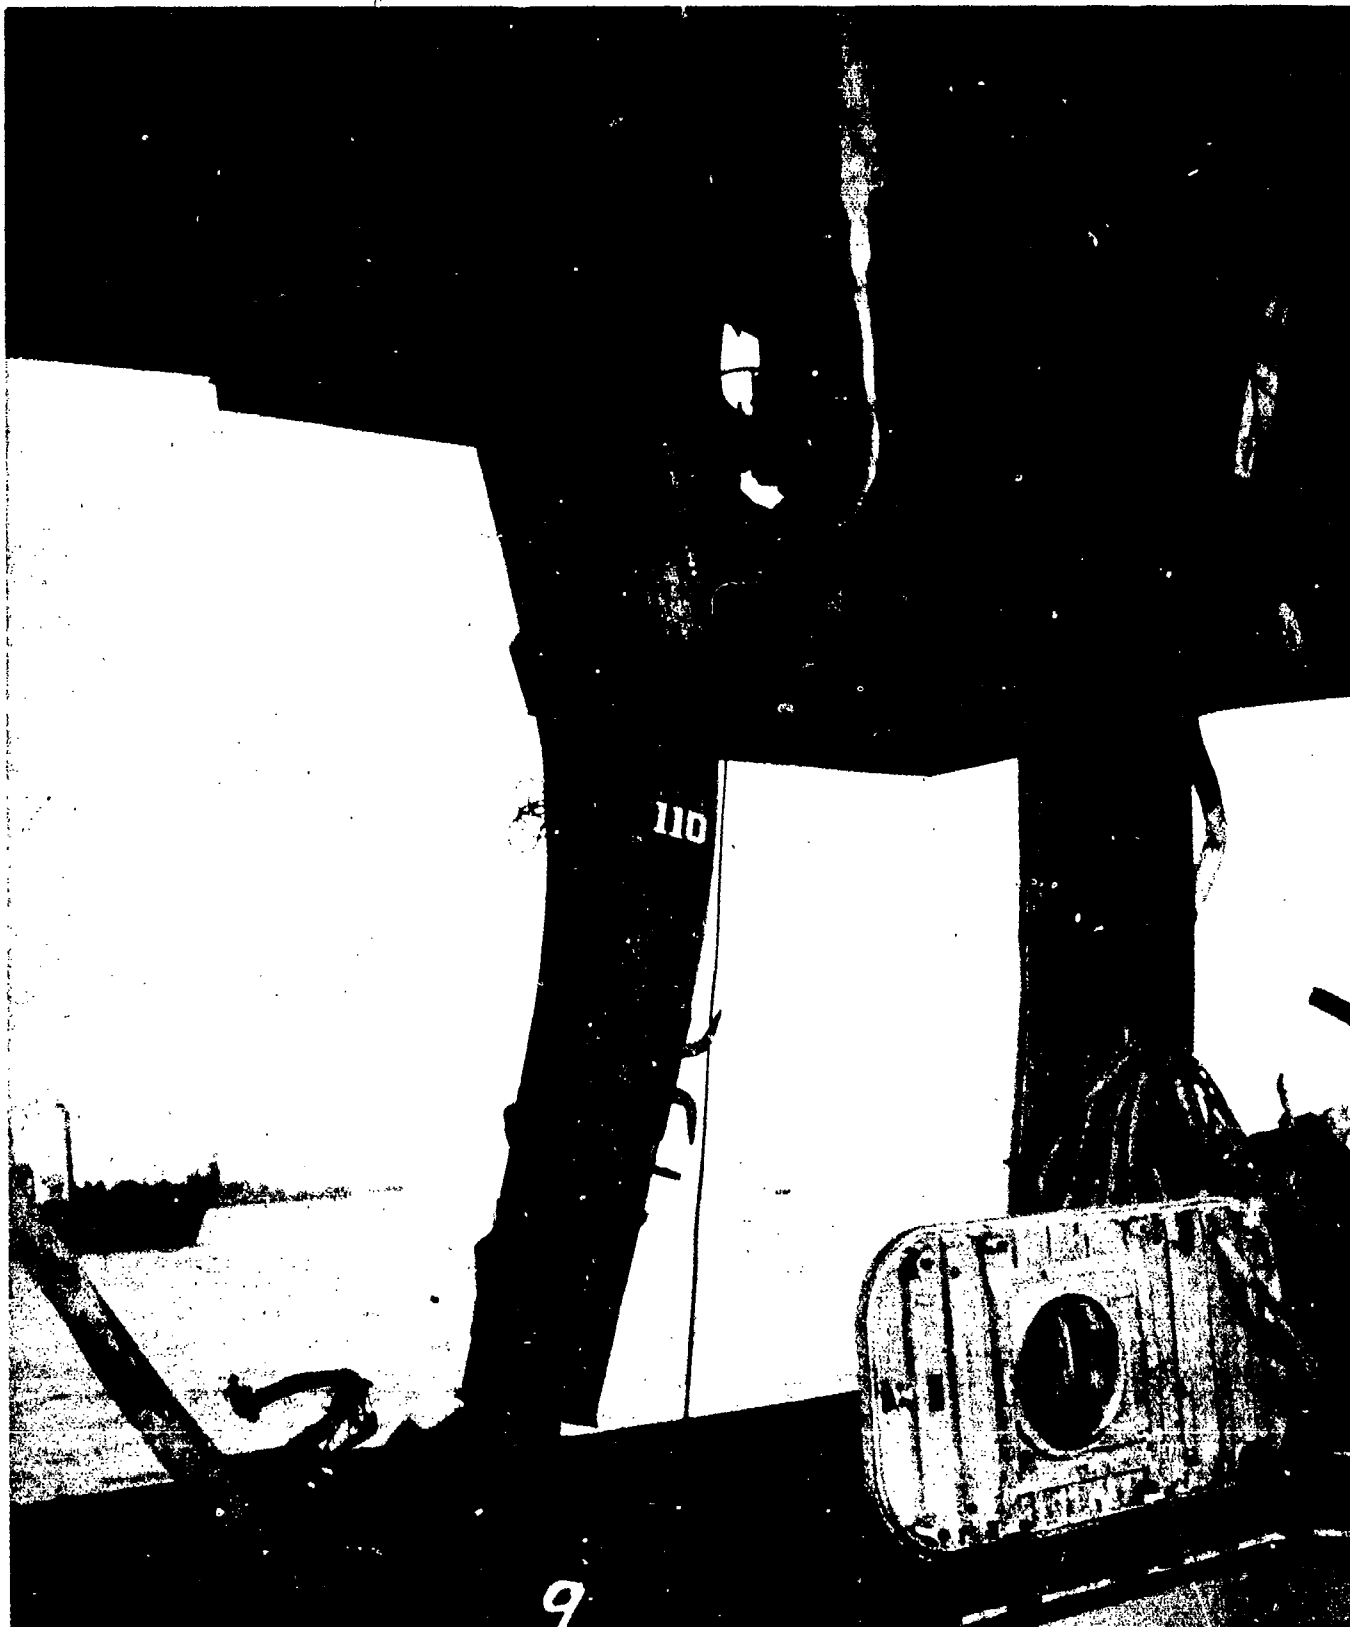
AA-CR-175-2131-9. Bent 110, port side, looking outboard from center-line.

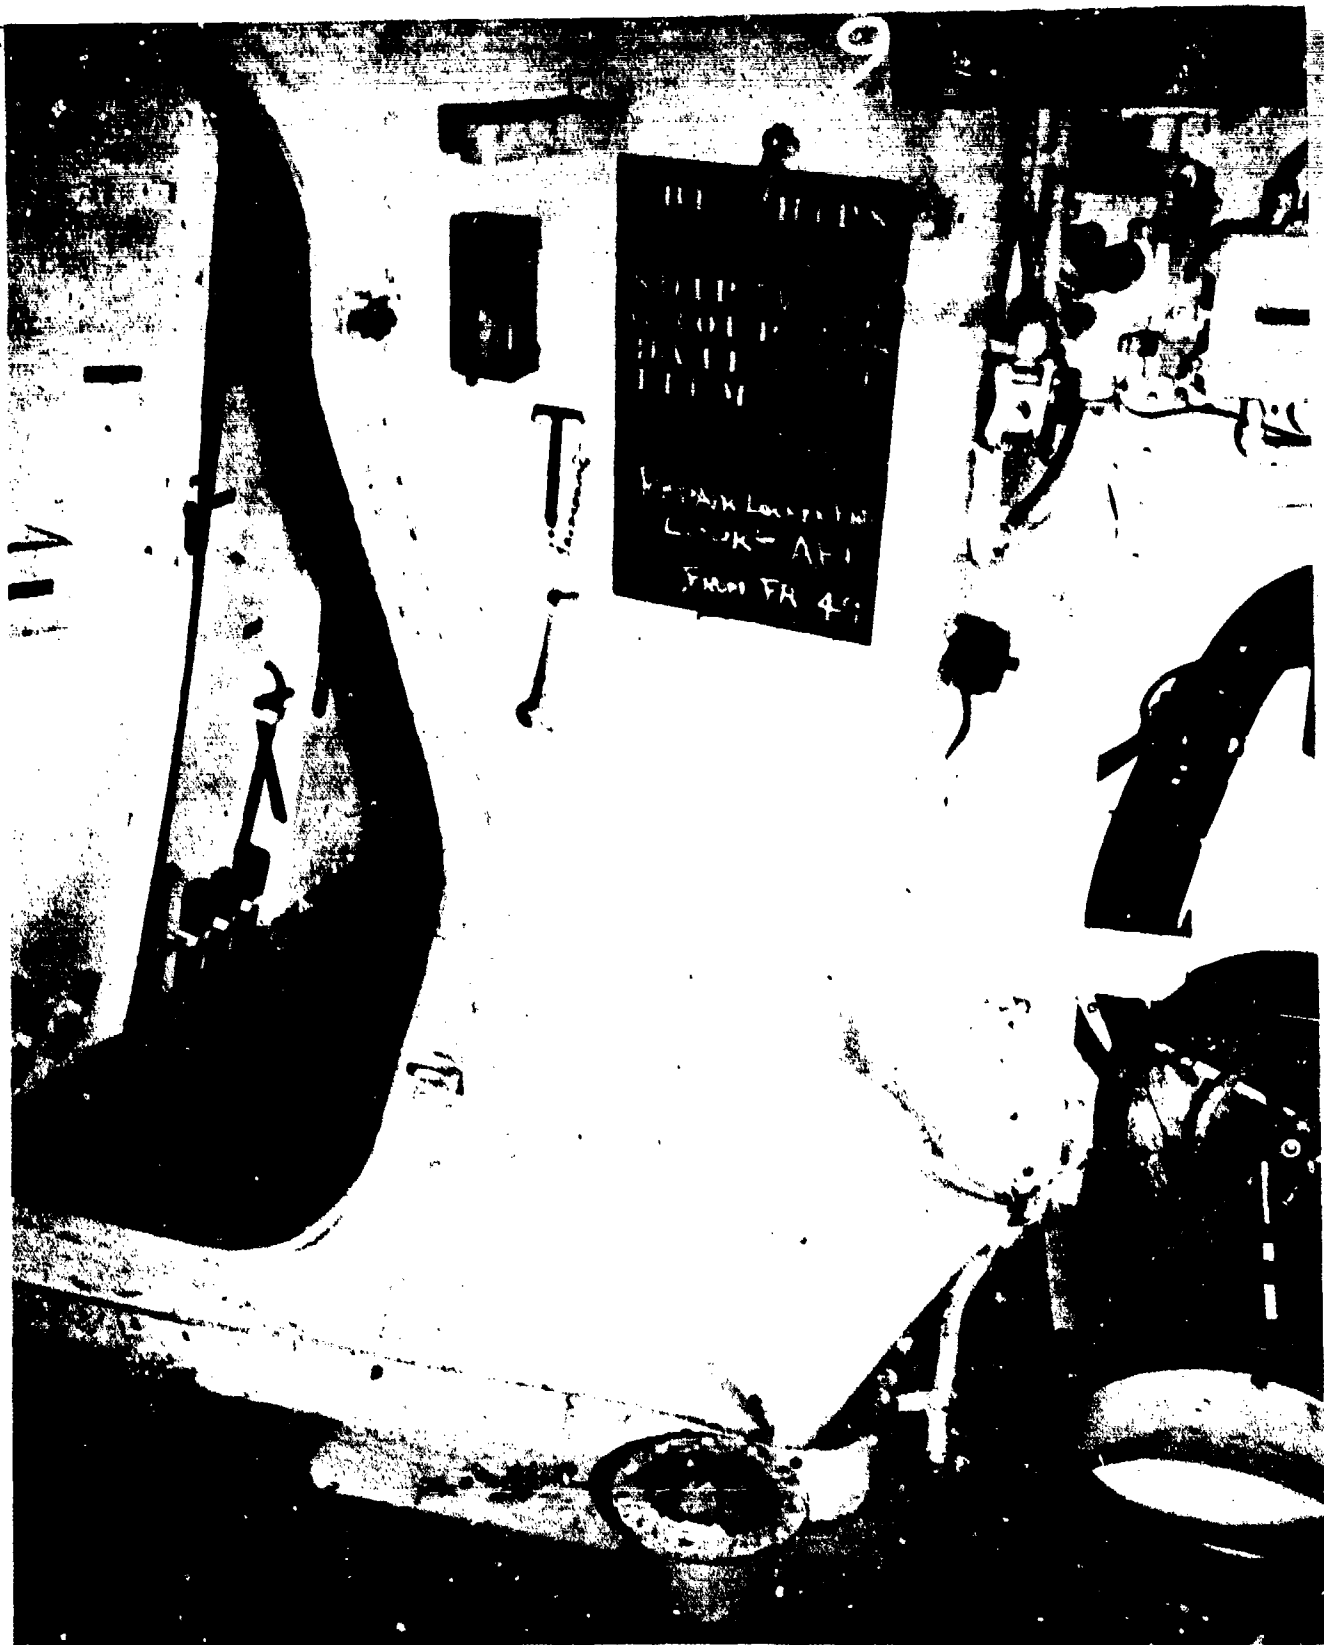
AA-CR-175-2133-6. Second deck, A-211-L. Looking aft from bulkhead 49 at repair party locker, frame 53, starboard side.

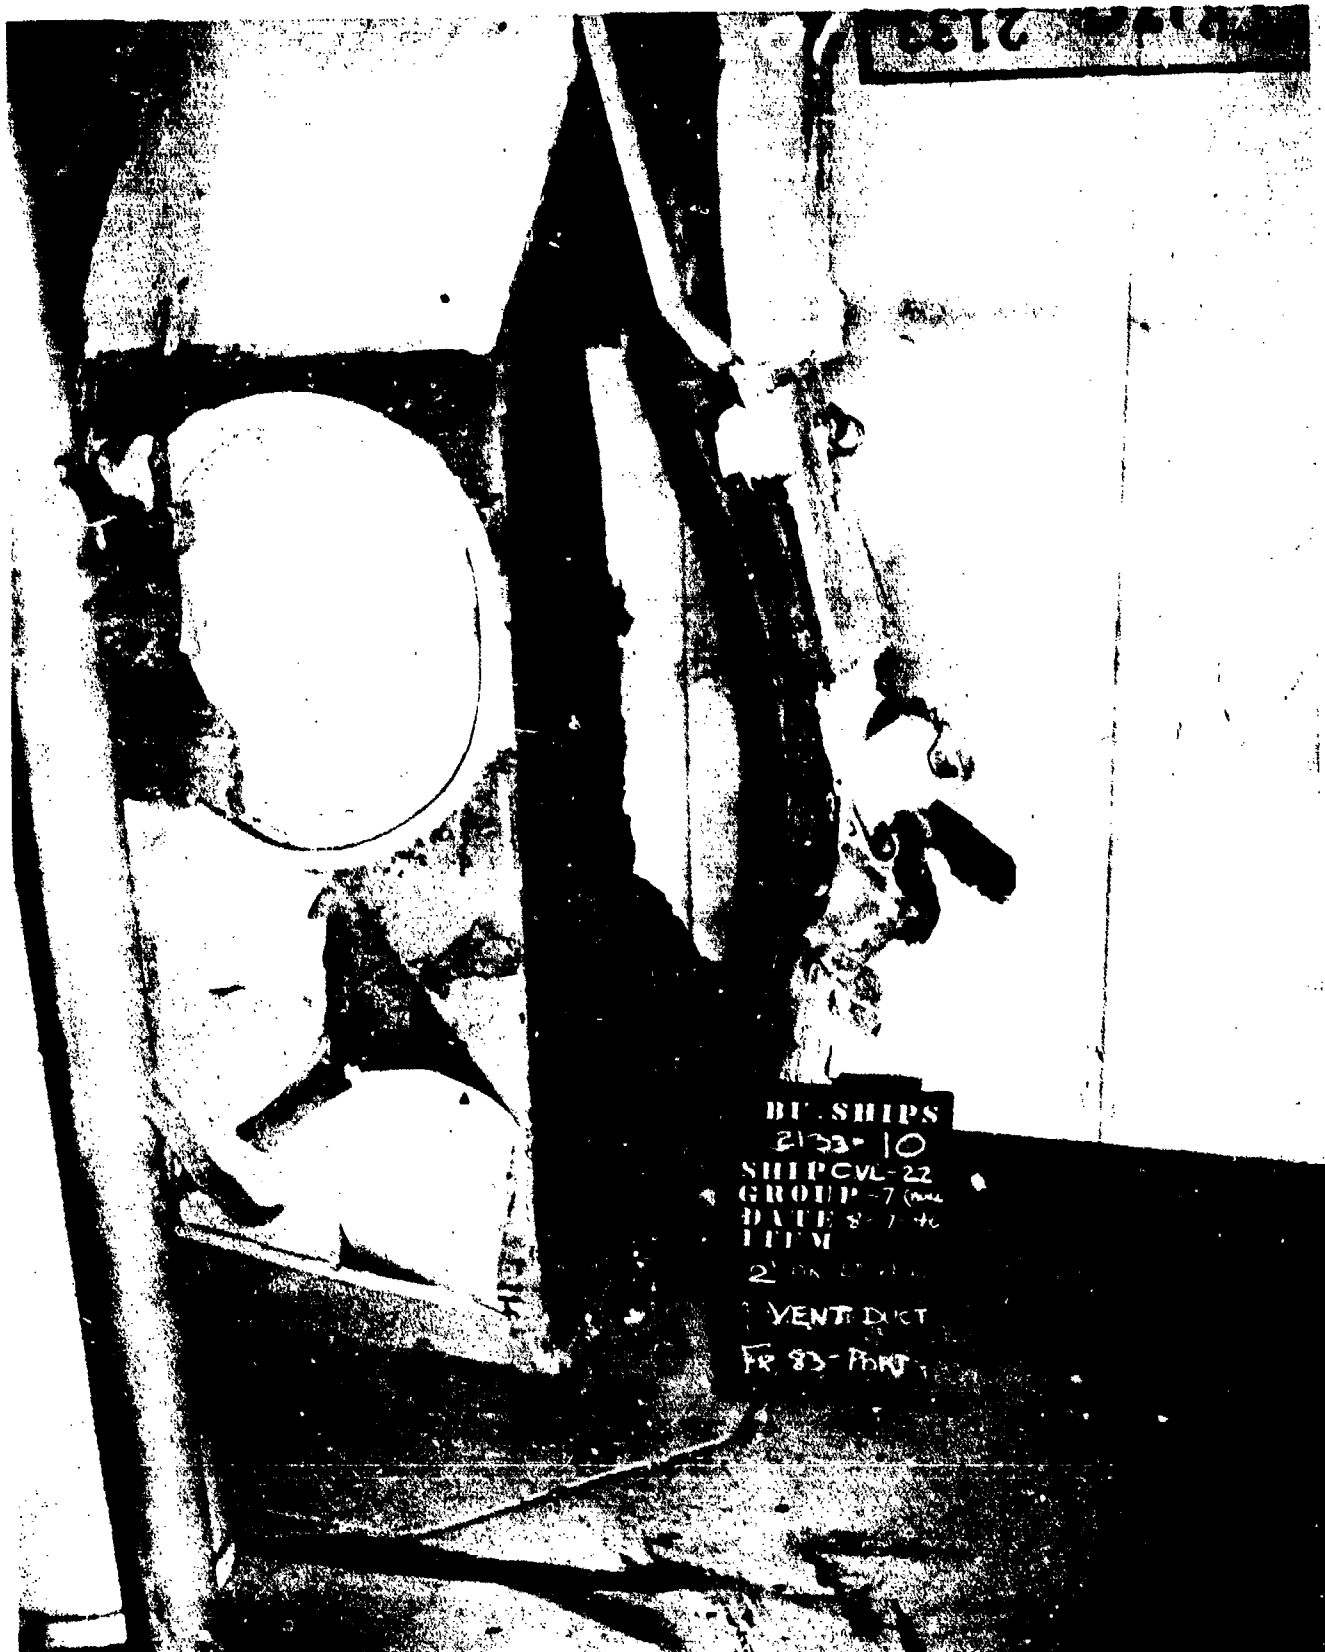
AA-CR-175-2133-10. Second deck, B-203-L. Blast damage to arc welded ventilation duct in mess attendants berthing space on port side at frame 83. Looking inboard and aft.

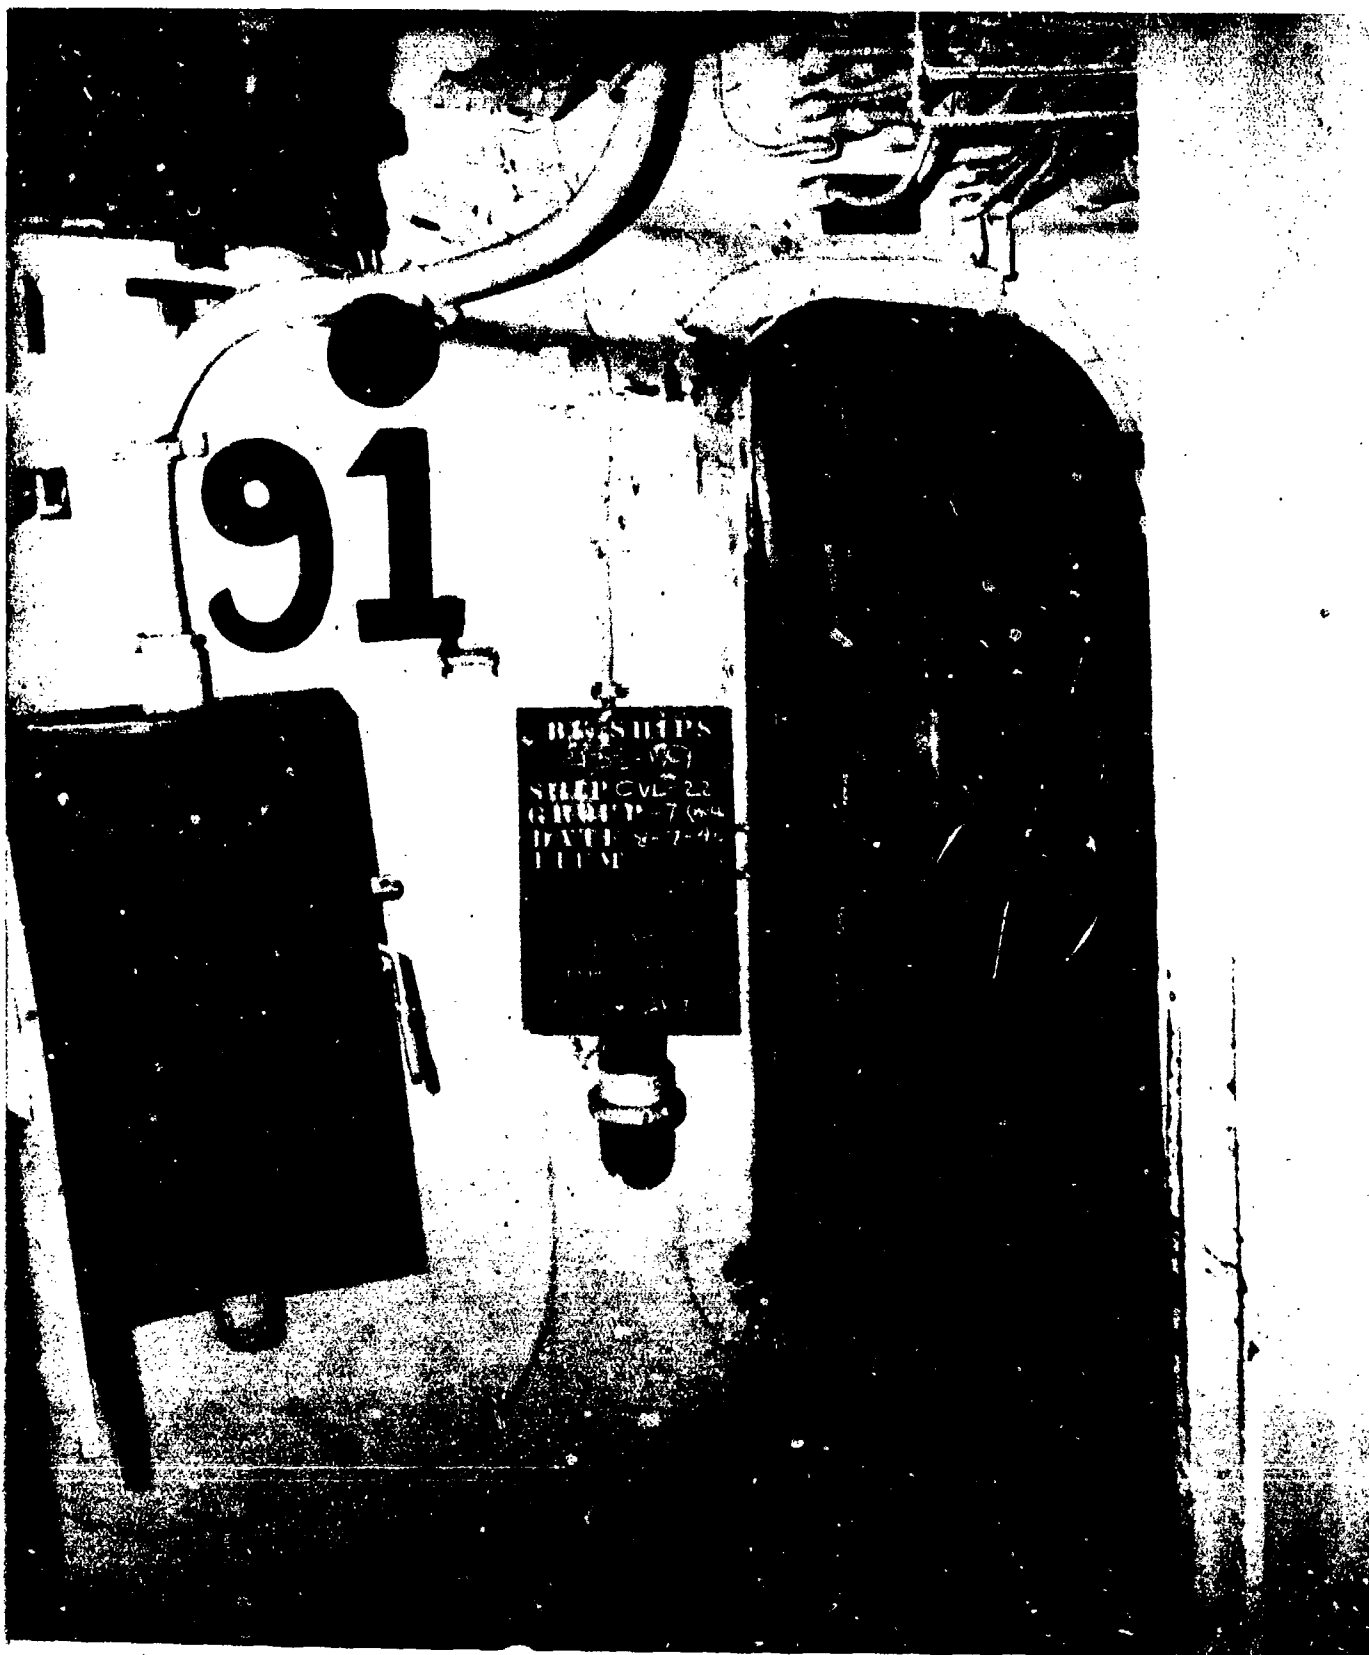
AA-CR-175-2133-9. Second deck, B-203-L. Port side passage, looking aft at bulkhead 91. Note W.T. door.

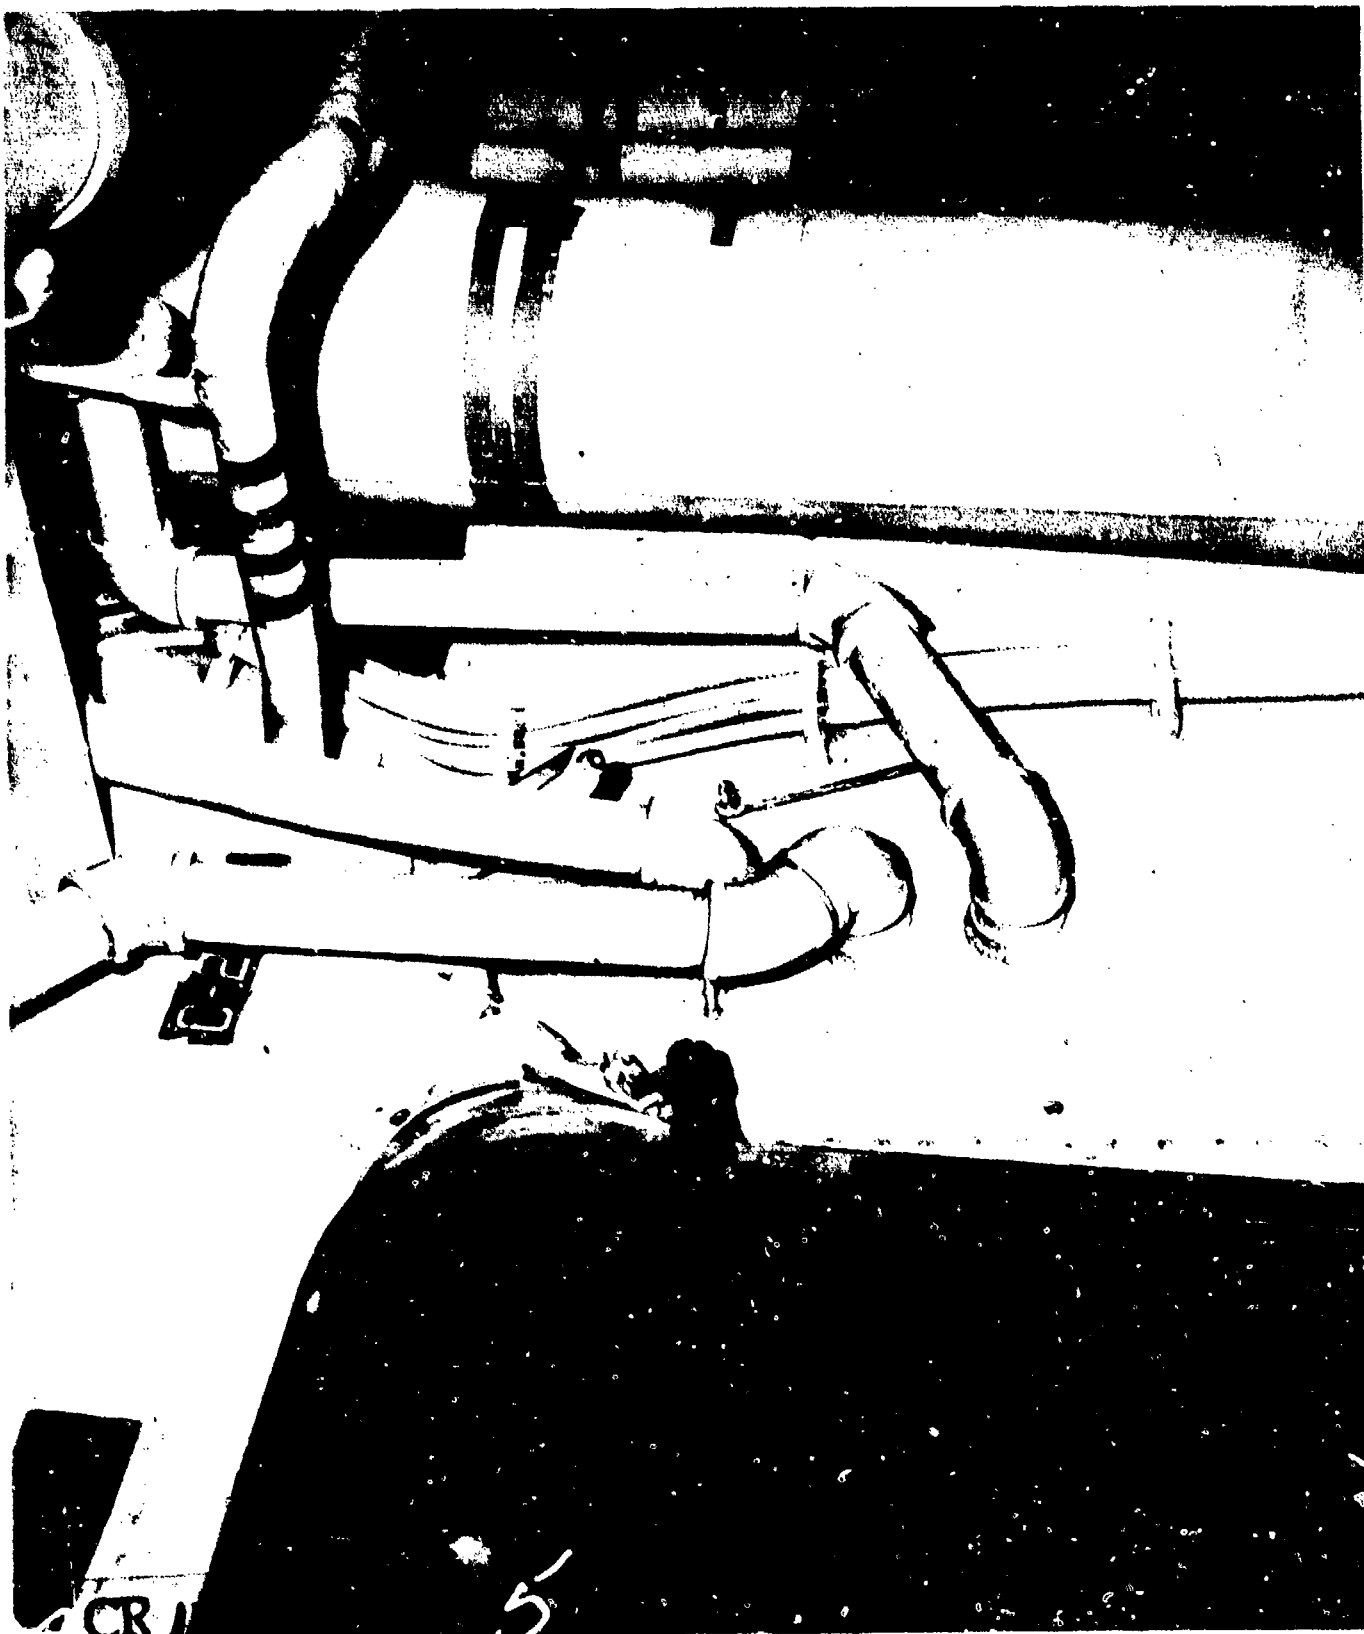
AA-CR-175-2115-5. Second deck, C-201-L. Looking forward on port side at W.T. door and bulkhead 101. Note buckle across top of door. For opposite side, see 2132-10.

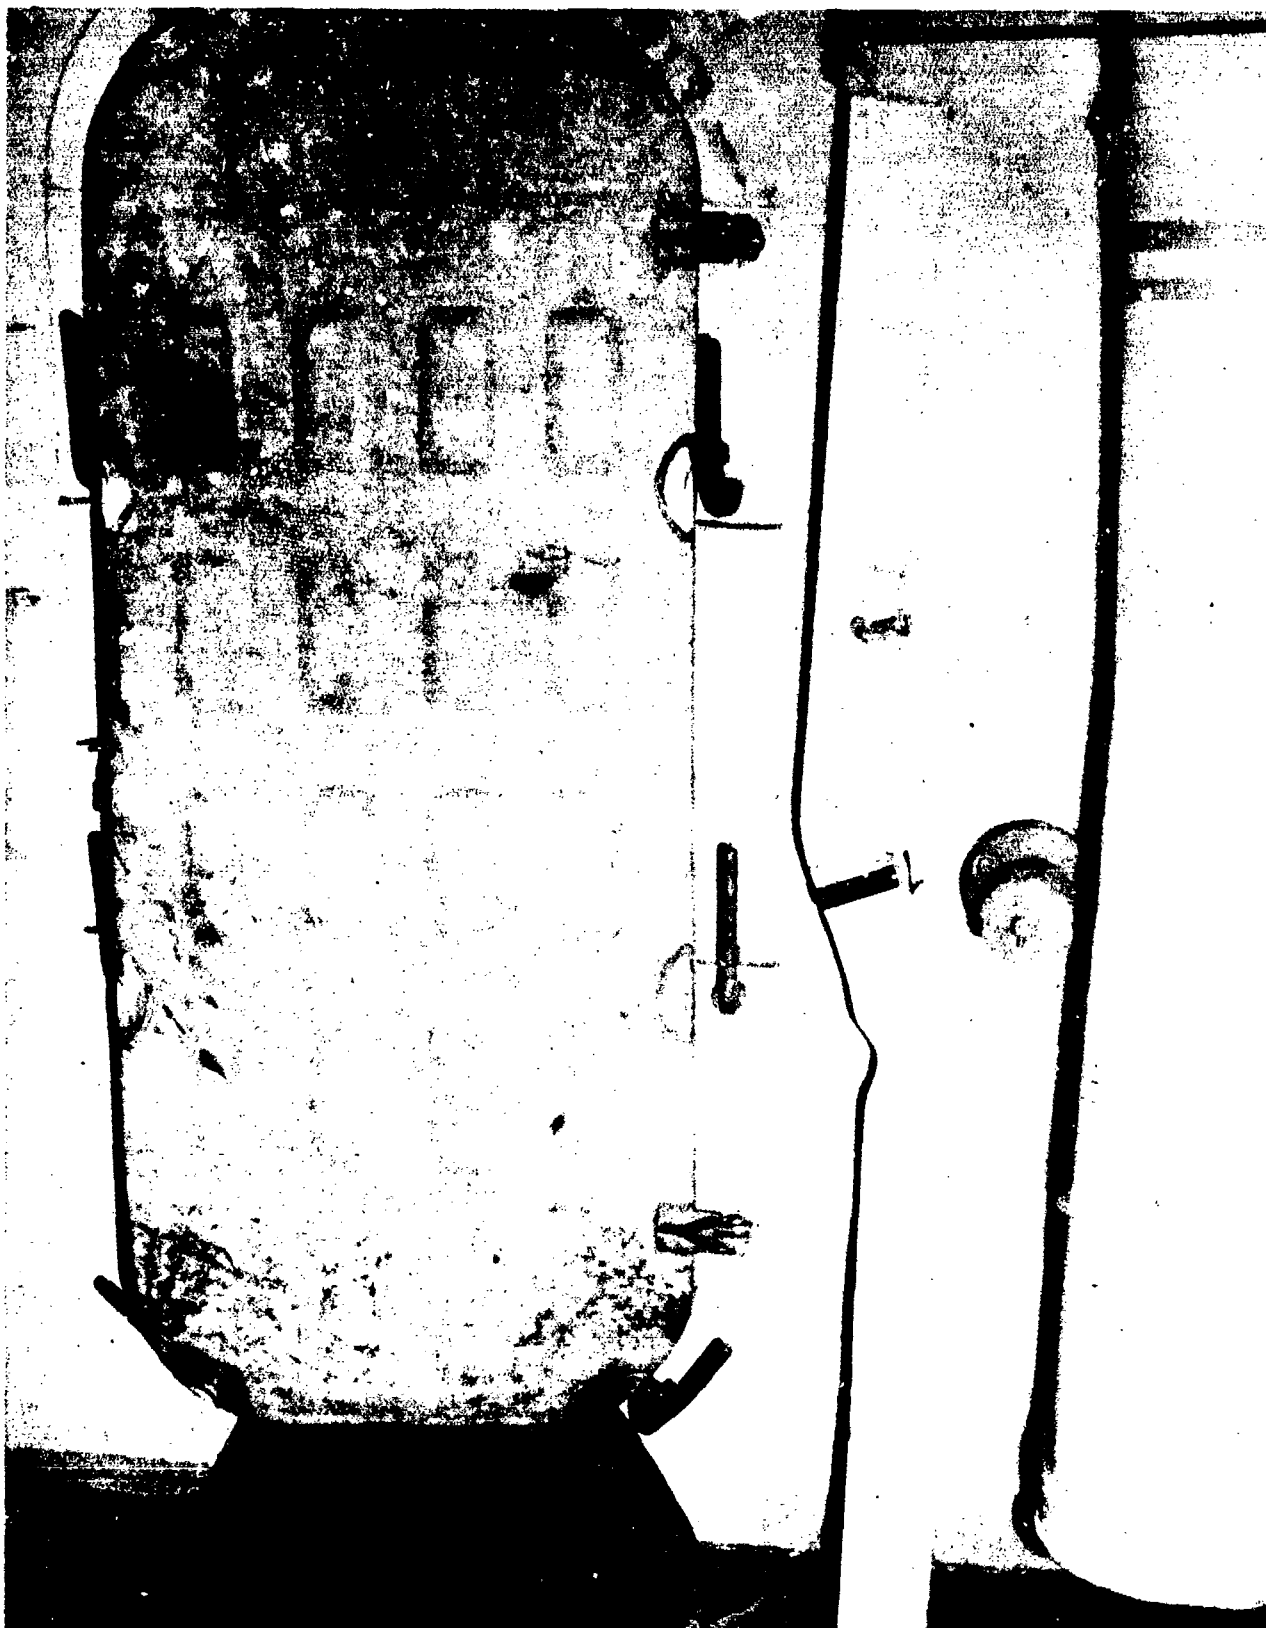
AB-CR-66-152-9. After Baker. Third deck, C-309-L. Bulkhead 126, starboard side, looking forward. Wrinkle runs from high inboard to low outboard.
